Technical information

Date: 29.08.02
No.: 01/02

Subject:
HOT GAS DEFROST, TEMPERATURE PROBE

Models:
STARFOOD

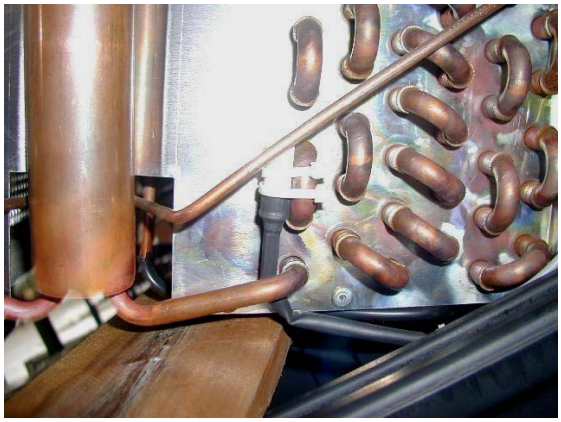
Fig. 1

Due to oxidation problems on probe connections noticed on several Starfood cooling units, after some tests, we were be able to observe that it was caused by condensation on hot gas probe connections between the insulating sheath and the probe wiring (Fig. 1).

The machine displays the error "Hot gas probe" on the user display.

Due to the condensation water on the terminals, the machine sees the probe as being short circuit and therefore displays the message above.

To avoid the problem, probes have been positioned the evaporator in a different way and also, the sheaths have been lengthened.

Therefore, if some cooling unit should have this kind of problem, we suggest replacing and repositioning the hot gas probe, as shown in Fig. 2.

The part number for the replacement probe is 986060
